Gering-Fort Laramie Irrigation District Tunnel #1, #2 and #3 Rehabilitation

Gehring-Fort Laramie Irrigation District
Annual Meeting
March 5, 2020

ANDERSON CONSULTING ENGINEERS, INC.

Tunnel #2-Failure Summary

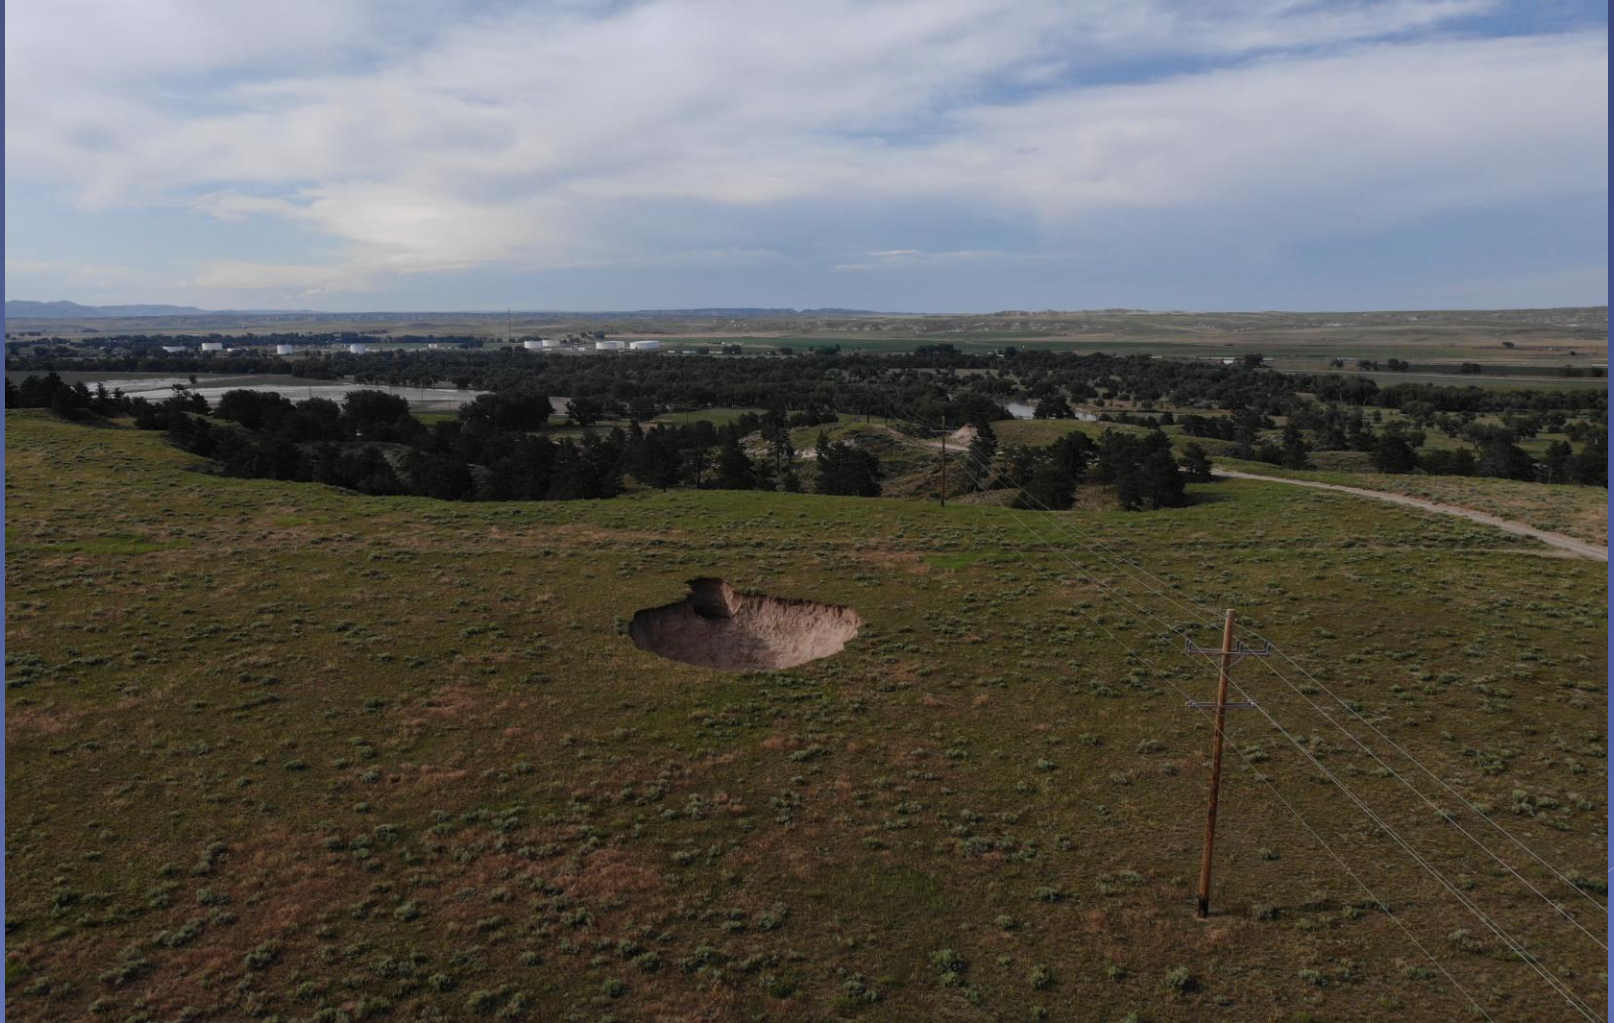
SINKHOLE PHOTO #1

- Failure on July 17, 2019
- Flow in canal estimated at 1,350 cfs
- Tunnel collapse, 1000 ft of debris blockage
- Sink hole in overburden
- Upstream canal breach due to blockage

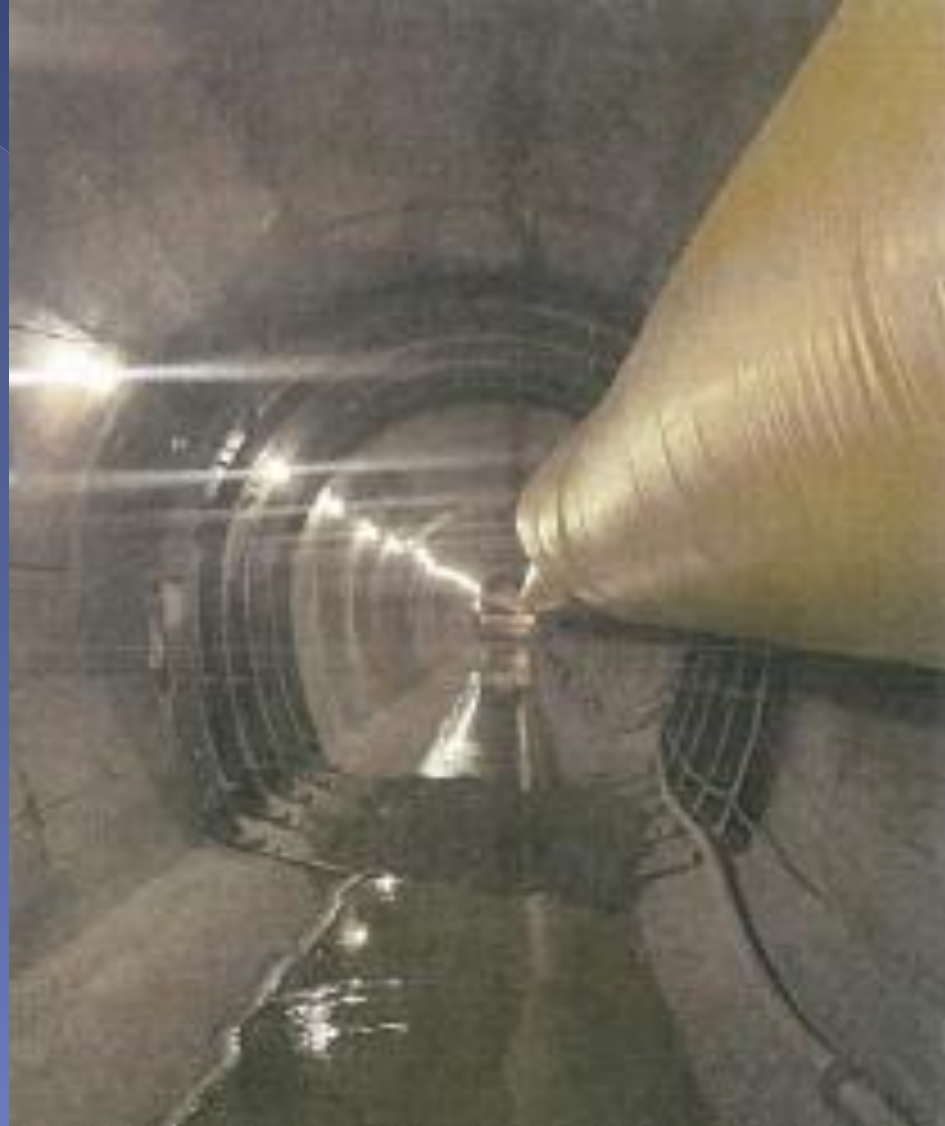
Steel Ribs at 400 feet from Tunnel #2 Inlet

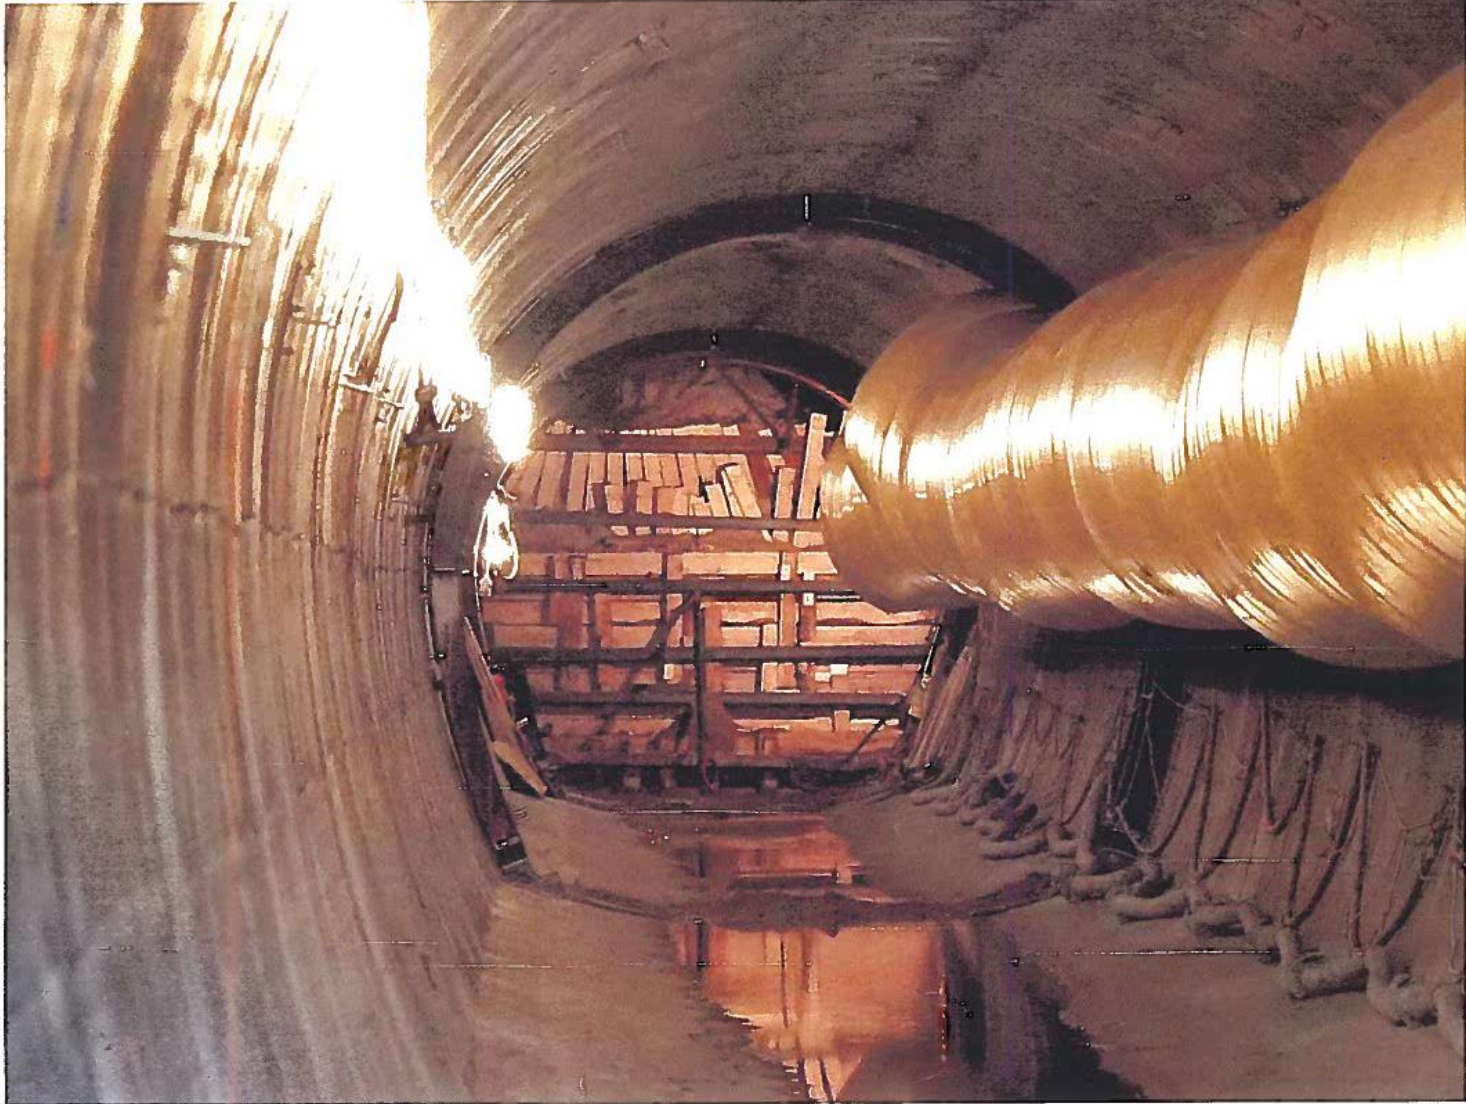
Station 6+20-Bulkhead at First Lining Failure

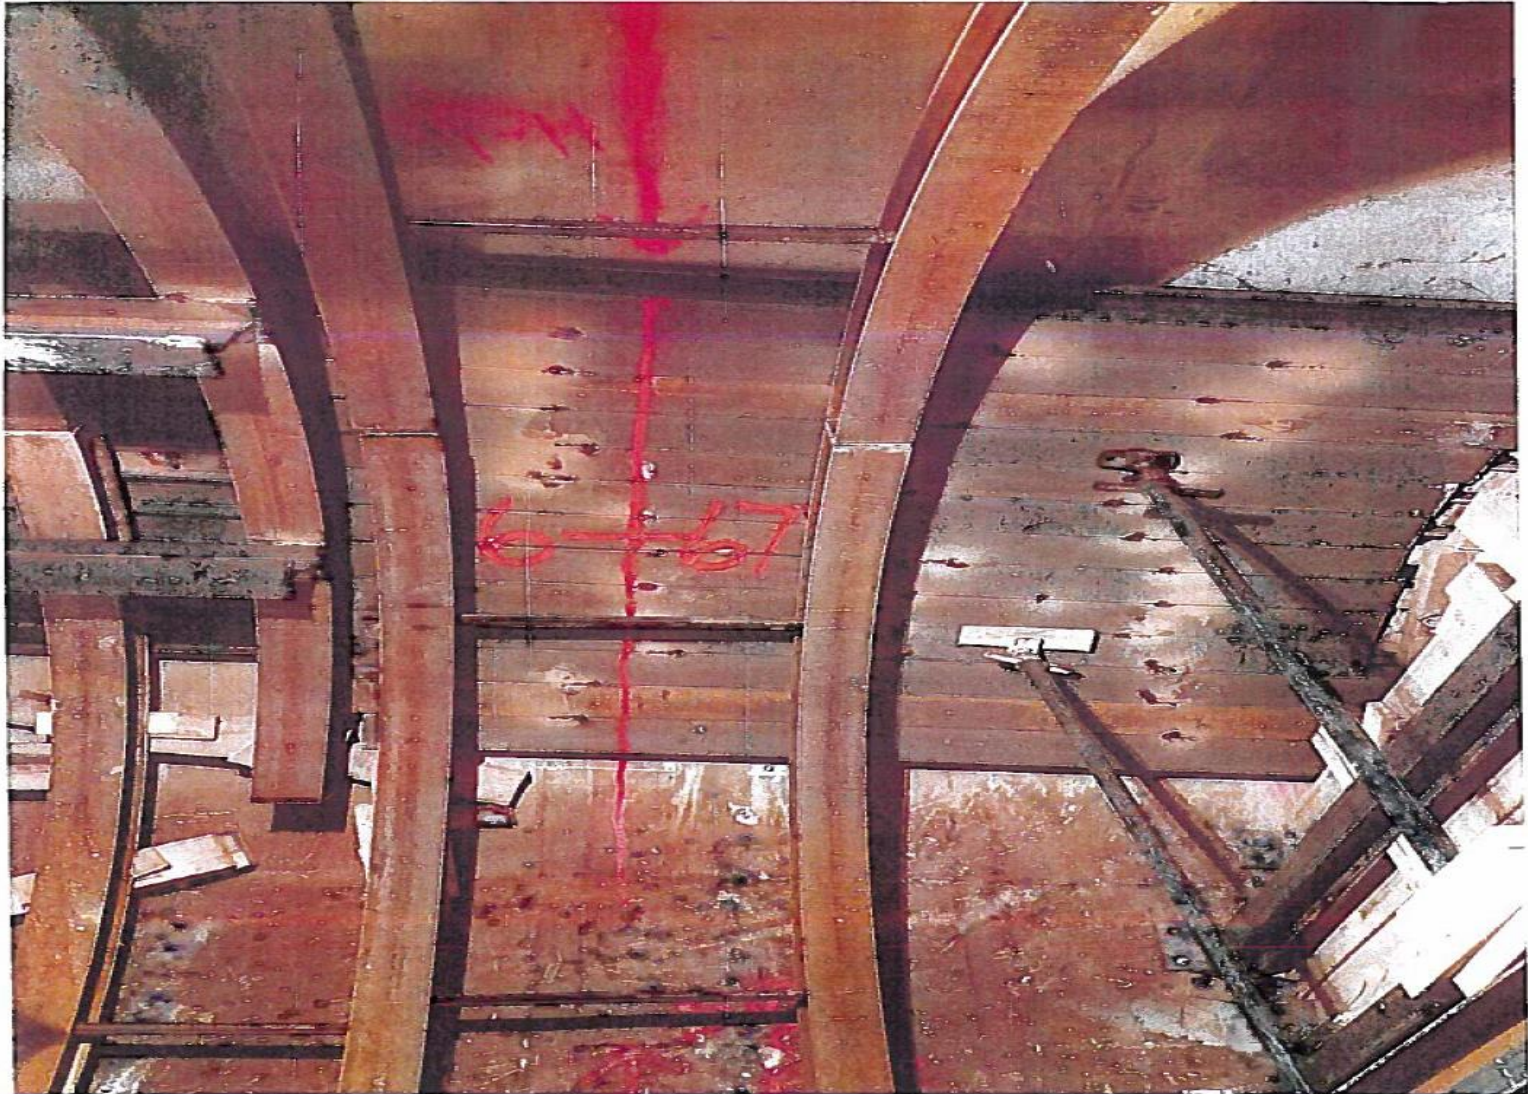
Steel Ribs & Reinforcement at First Lining Failure

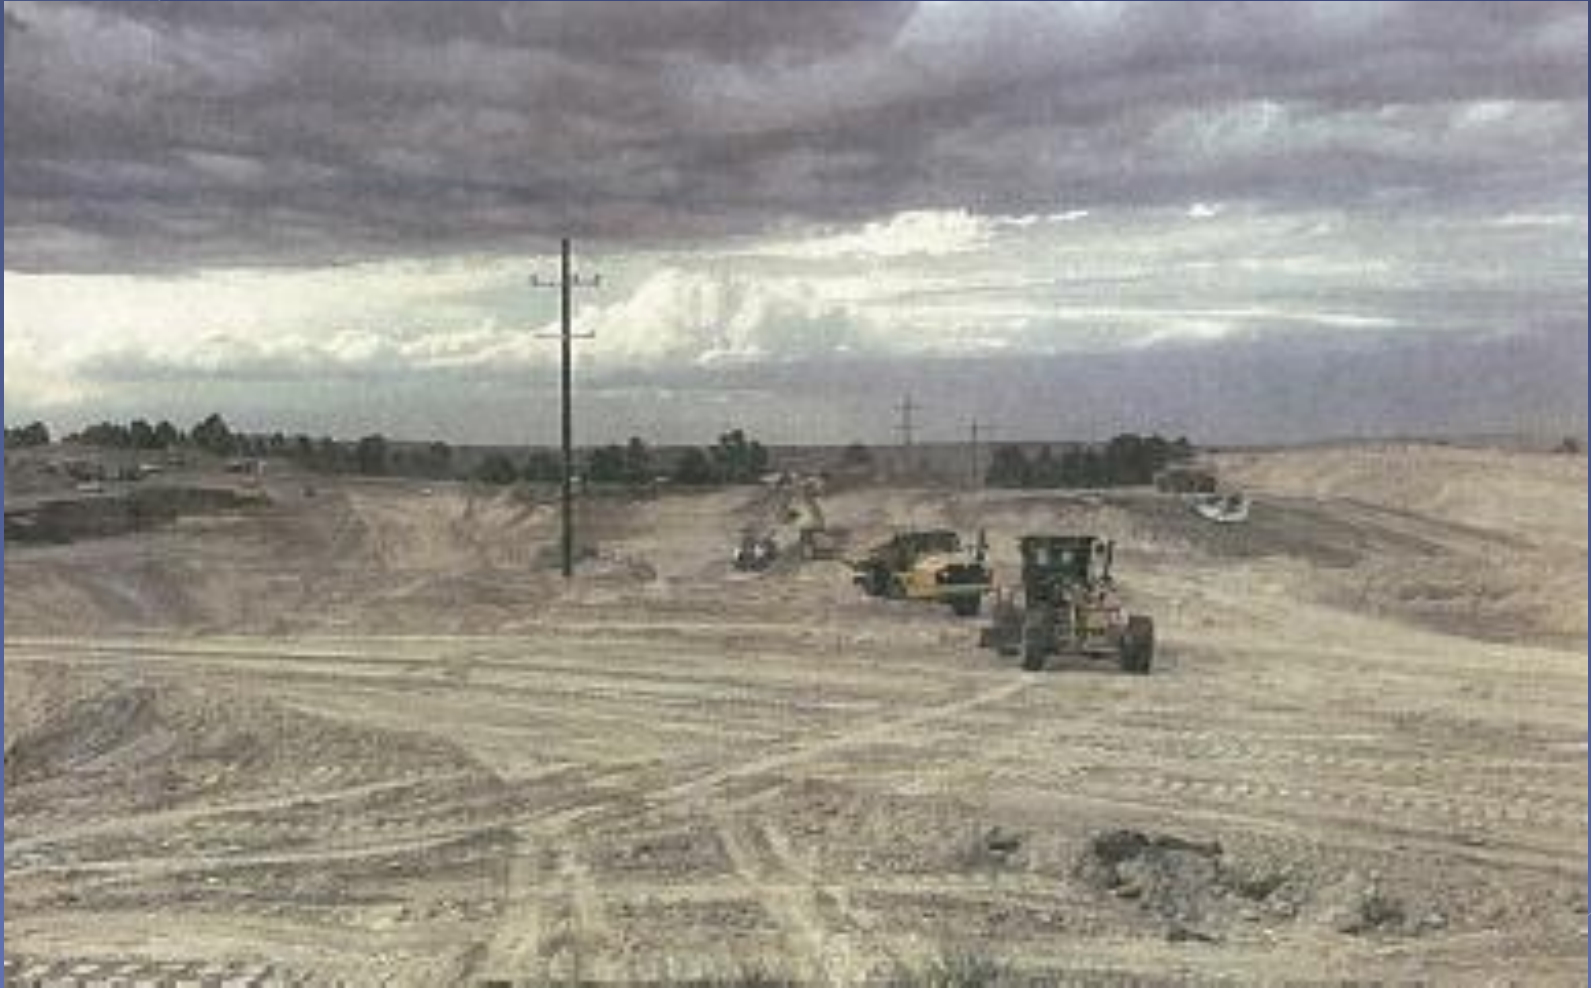
Excavation Above Tunnel #2 Failure
